Repair of Utility Cuts Using Interlocking Concrete Pavers

Utility Cut Repairs in Asphalt Pavements Using Interlocking Concrete Pavers

Repair Guidelines for Using Concrete Pavers for Utility Cuts in Asphalt Pavement

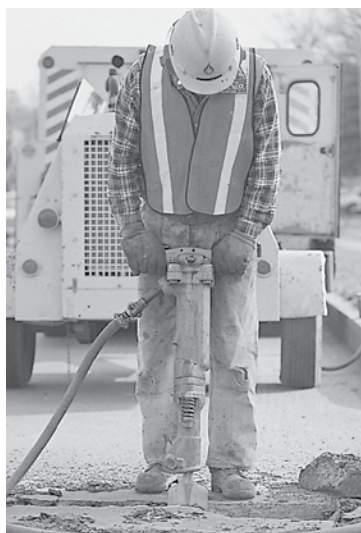
Figure 1. Repairs to utilities are a common sight in cities, incurring costs to cities and taxpayers.

North American cities have thousands of utility cuts made in their streets each year. Figure 1 shows a daily occurrence in most cities: repairs to underground utility lines for water, sewer, gas, electric, steam, phone, fiber-optic, or cable services. A sample is given below of the number of annual utility cuts in a few cities.

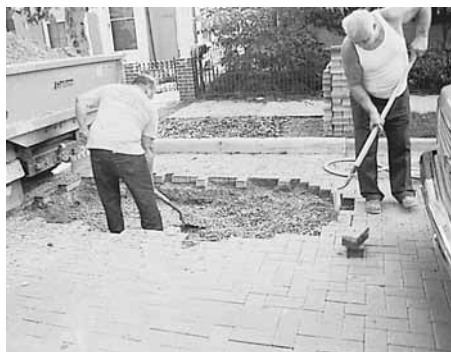
Figure 2. Removal of concrete pavers for a gas line repair in Dayton, Ohio.

Figures 2, 3, 4, 5 and 6 show the process of repair and illustrate the continuity of the paver surface after it is completed. The reinstated units are knitted into existing ones through the interlocking paving pattern and sand filled joints. Besides providing a pavement surface without cuts, the joints distribute loads by shear transfer. The joints allow minor settlement in the pavers caused by discontinuities in the base or soil without cracking.

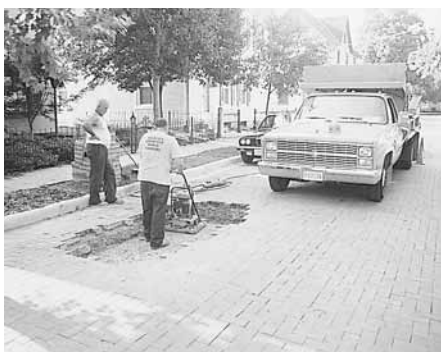
Figure 3. Compaction of the base

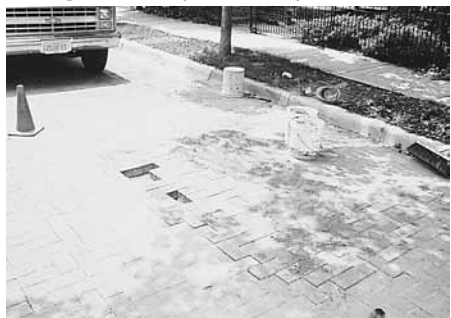
Figure 4. Reinstatement of the pavers, bedding and joint sand

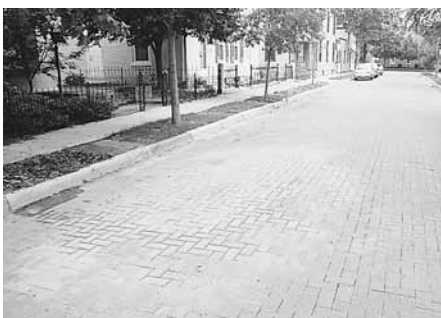
Figure 5. The final paver surface is continuous. There are no cuts or damage to the pavement.

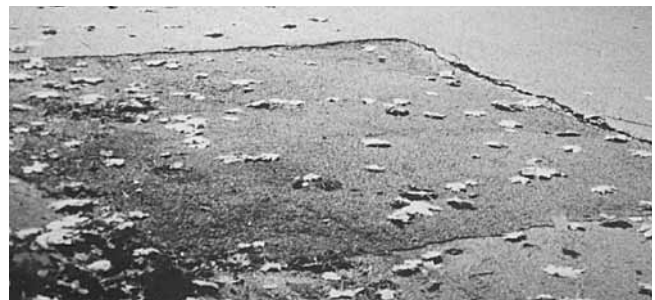
Figure 7. Pavement damage from settlement and shrinkage of cold patch asphalt.

Figure 7 shows the result of settlement and shrinkage of the cold patch asphalt in a London, Ontario, utility cut. The change in dimensions causes the edge of the cut asphalt to deteriorate, and settlement decreases riding quality.

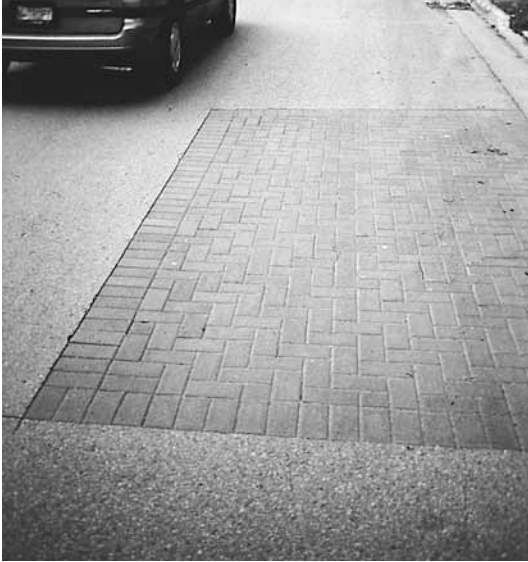
Figure 8. Utility cut repair in a residential area in London, Ontario.

Concrete pavers on low density concrete fill have been successfully used as a replacement for cold patch asphalt (Figures 8 and 9). They were first used as a temporary repair with the intent of being removed in the spring. However, the pavers performed so well that the City of London left them in place indefinitely. Several repairs were in streets subject to heavy truck traffic, as well as residential streets. Costs were less than using cold

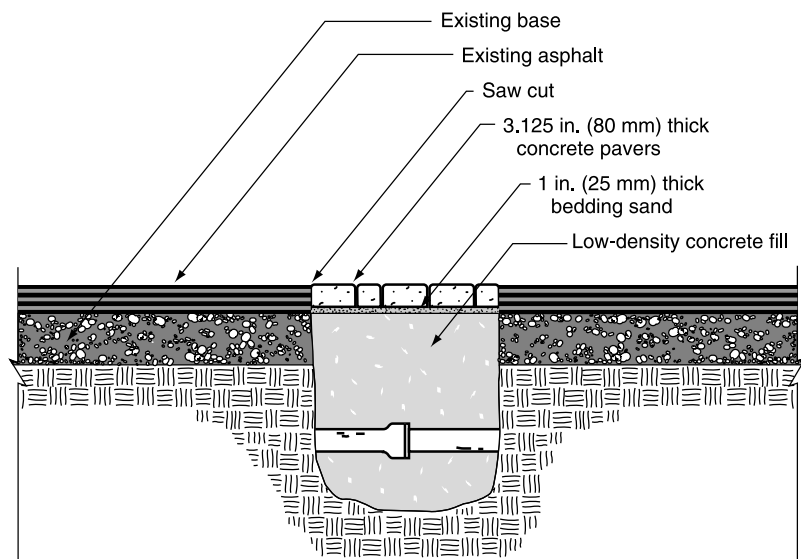
Figure 9. Cross section of utility cut repairs with concrete pavers in London, Ontario

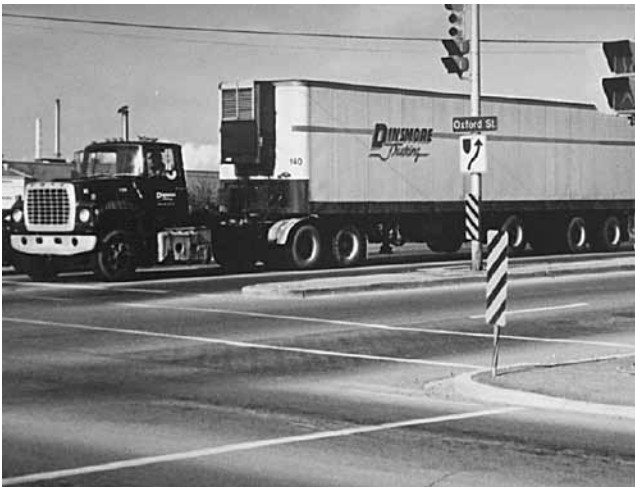
Figure 10. A patch of barely discernable pavers in a heavily trafficked intersection in London, Ontario

All repairs in London with concrete pavers and low-density concrete have produced a smooth surface transition from the asphalt to the pavers. The riding quality and safety has improved to the extent that the transition from one surface to the next can barely be discerned by the driver. The pavers were colored to match the appearance of the asphalt so there would be no substantial differences in appearance. Figure 10 shows such a patch of pavers blending with the surrounding pavement.

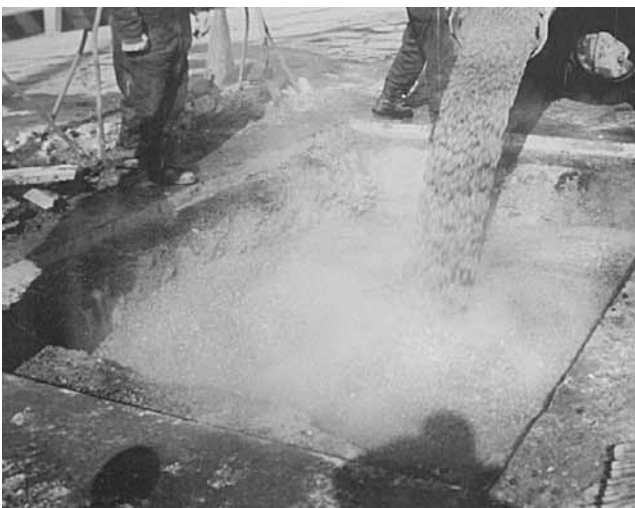
Figure 11. Low density concrete fill (unshrinkable fill) poured into a utility trench from a ready-mix concrete truck.

Unshrinkable fill poured into the trench is shown in Figure 11. The fills flows into undercuts, under the edge of the cut asphalt (providing additional support), and in places where the soil or base has fallen from the sides of the trench. These places are normally impossible to fill and compact with aggregate base or backfill material.

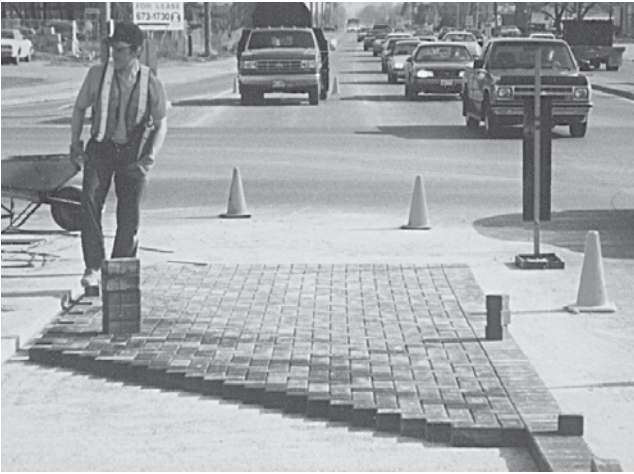
Figure 12. Pavers are laid in a 90 degree herringbone pattern between the border courses.

Place pavers between the border course in a 90 degree herringbone pattern (Figure 12). Joints between pavers should not exceed 1/16 in. (2 mm). Compact the pavers with a minimum 5,000 lbf (22 kN) plate compactor. Make at least two passes with the plate compactor. A small test area of pavers may need to be compacted to check the amount of settlement. The bedding sand thickness should be adjusted in thickness to yield pavers no higher than 1/8 in. (3 mm) above the edge of the asphalt.

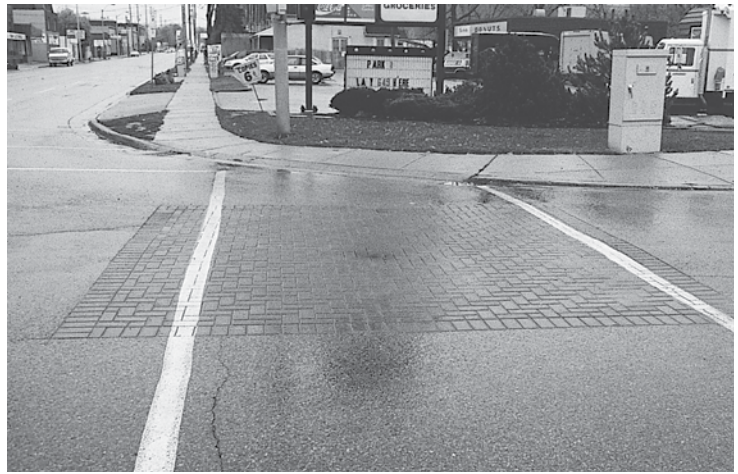
Figure 13. Concrete pavers in utility cuts can be painted as any other pavement.

lane, traffic, or crosswalk markings as any other concrete pavements (Figure 13).
