# ICPI TECH SPEC

## NUMBER 7

## Repair of Utility Cuts Using Interlocking Concrete Pavers

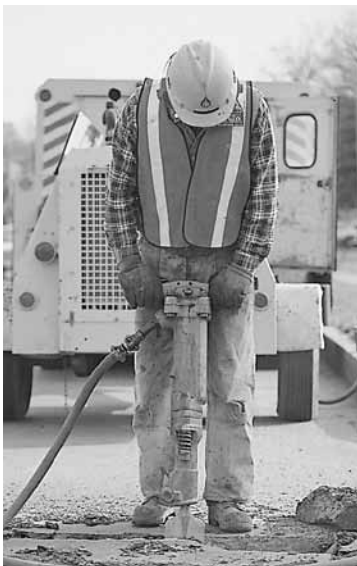
Figure 1. Repairs to utilities are a common sight in cities, incurring costs to cities and taxpayers.

North American cities have thousands of utility cuts made in their streets each year. Figure 1 shows a daily occurrence in most cities: repairs to underground utility lines for water, sewer, gas, electric, steam, phone, fiber-optic, or cable services. A sample is given below of the number of annual utility cuts in a few cities.

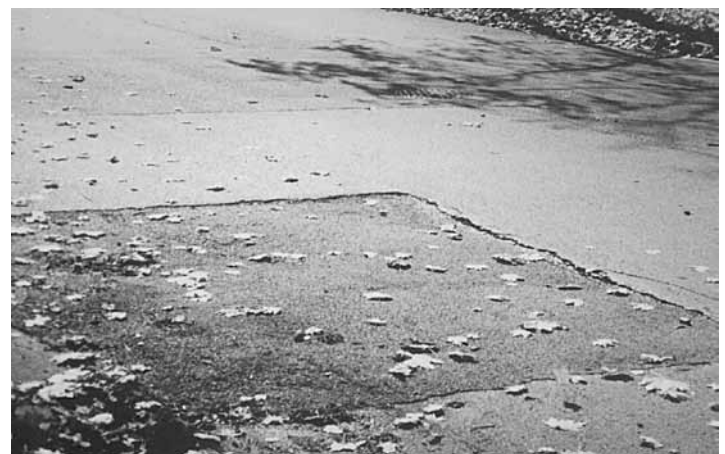
Figure 7. Pavement damage from settlement and shrinkage of cold patch asphalt.

Figure 7 shows the result of settlement and shrinkage of the cold patch asphalt in a London, Ontario, utility cut. The change in dimensions causes the edge of the cut asphalt to deteriorate, and settlement decreases riding quality.
